ATTACHMENT 6 – SITE AUDIT REPORT

SITE AUDIT REPORT

**20 Hely Avenue, Turvey Park NSW
Remediation Action Plan**

Date: July 2020

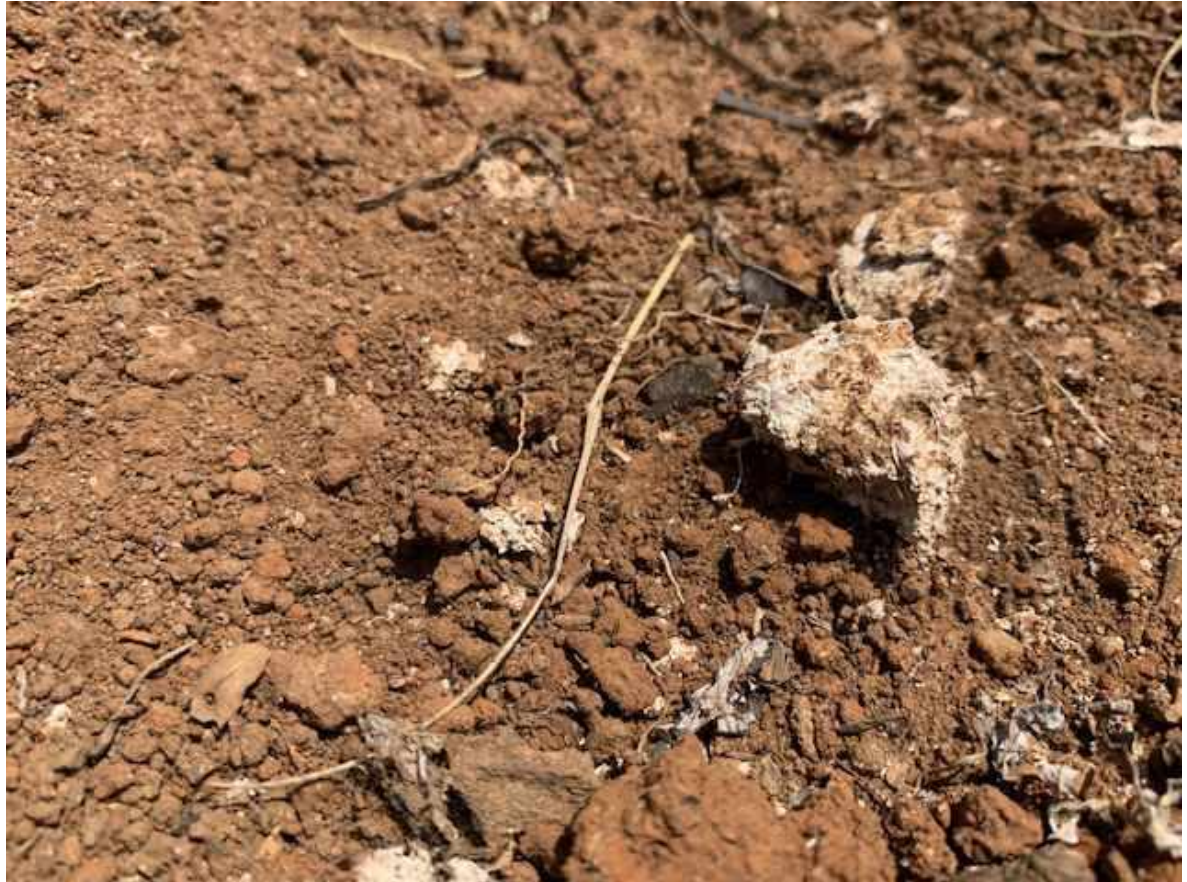
| Asbestos Area | Surface Inspection | Testpit Results |
|---|---|---|
| | | <p>text of the DSI as "pipe lagging" and analysis by the laboratory reported asbestos fines (AF & FA) at a concentration of 2.42%w/w.</p> <p>Fill noted across much of this area (3/7, 3/8, 3/9, 3/10, 3/12-3/16, 3/18-3/21, 3/23, 3/28-3/31) possibly due to the recent demolition of the fire damaged building.</p> |

Photo 1. Fibrous lagging within Pit 347

| Table 9.2: Preferred Remediation Options | | | |
|---|--|---|---|
| Fibrous asbestos impacted soil. | Within the footprint and immediate vicinity of former building 503 (recently fire damaged and demolished). An area of fibrous asbestos (reported as pipe lagging) adjacent to Building 503 and fill within the former building footprint to a depth of 0.1m (Attachment 16). Source considered to be improper asbestos removal works undertaken prior to demolition. | Excavation of the identified fibrous asbestos, stockpiling for waste classification prior to off-site disposal to a licensed waste management facility. | Excavation Area: <ul style="list-style-type: none"> Visual inspection and "emu pick" by a licensed asbestos assessor. Collection of surface samples at a rate of 1 per 10m² across the excavation area. Analysis for AF/FA (500mL samples). |

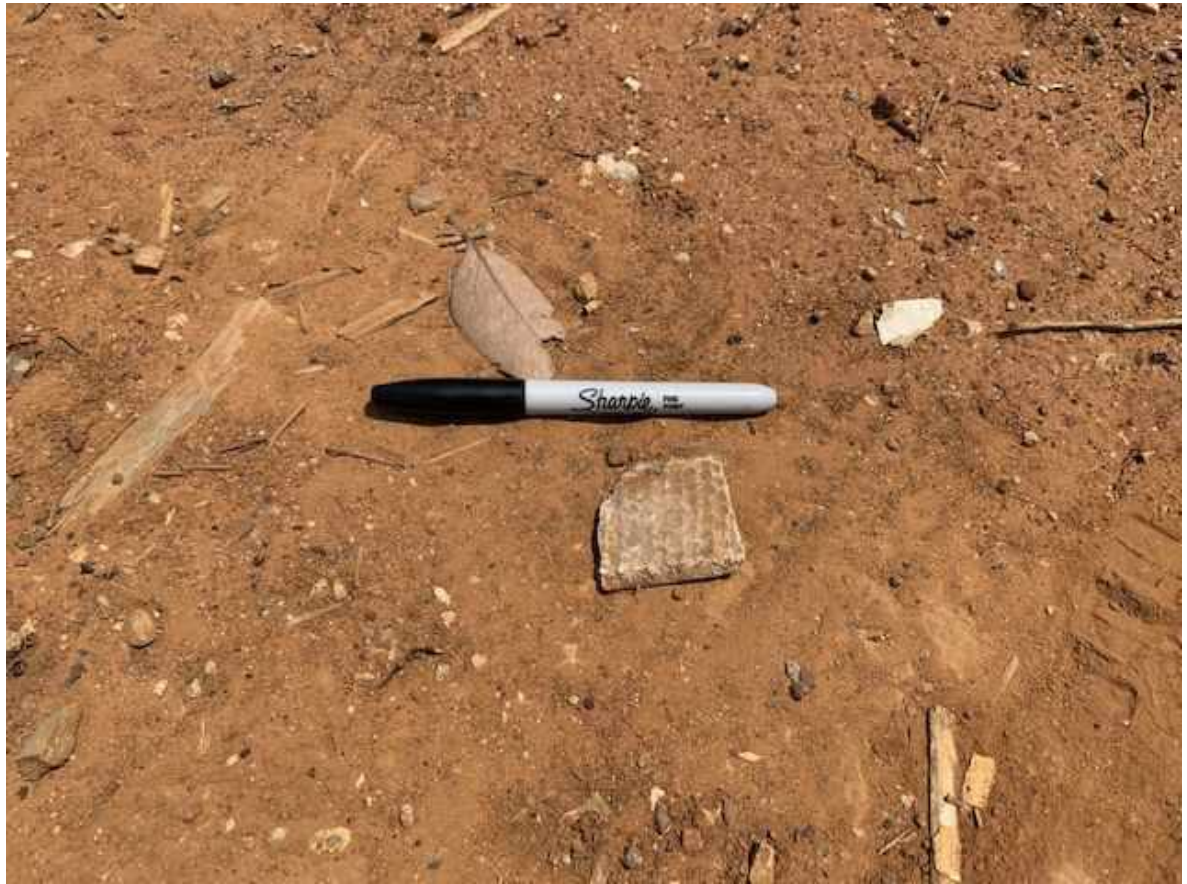
Bonded ACM fragments were found within 120 of the 1,138 grid squares inspected (Attachment 12). The results all reported concentrations of bonded ACM on the surface below 0.01%w/w. The ACM finds correlated well with areas of previous buildings. Based on the location of the surface ACM finds, MES identified specific areas for further investigation as discussed in section below.

Photo 2. Typical surficial bonded asbestos material observed at the site.

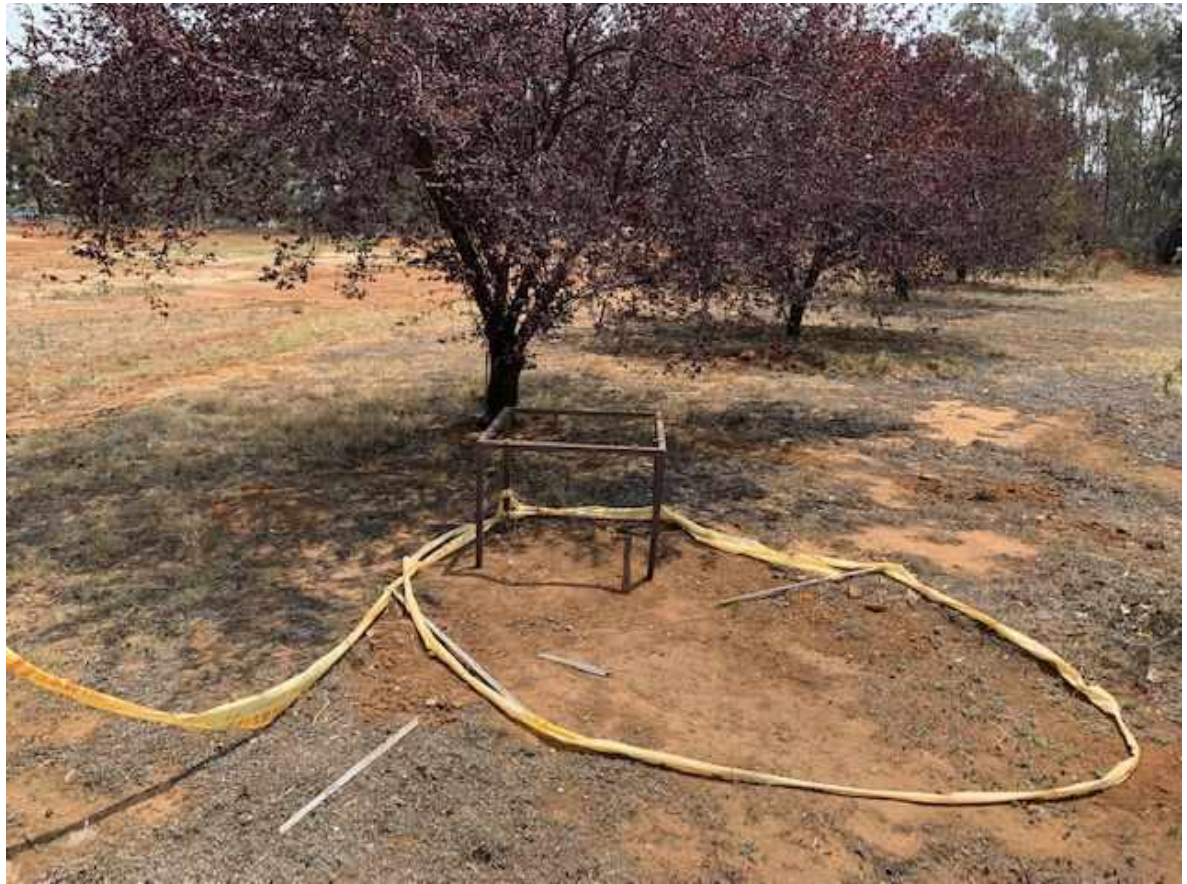
Photo 3. Pit 347, facing west-south-west.
