# **Douglas Partners**

Report on  
Desktop Geotechnical Assessment

Planning Proposal - Rowan Village  
7066 Holbrook Road, Rowan

Project 210894.01  
April 2022

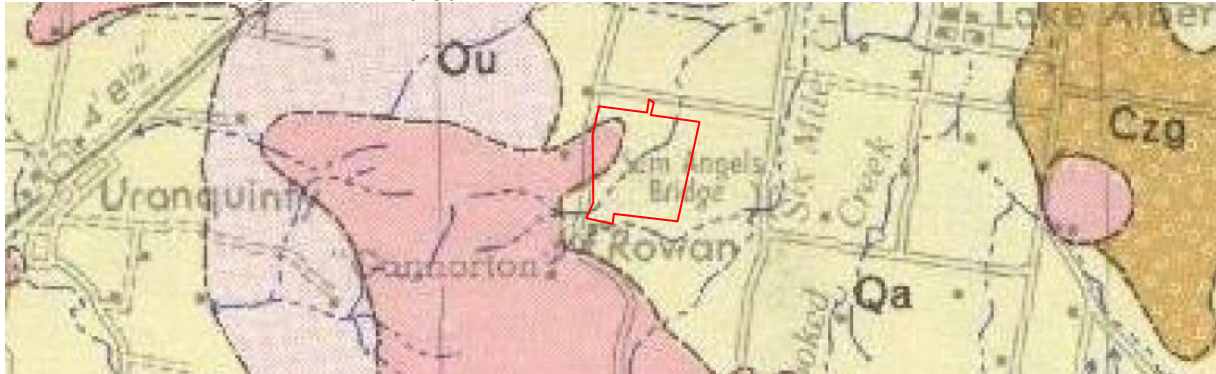
**Figure 2: 1966 Wagga Wagga 1:250,000 Geology Map with approximate site location (outlined in red). Alluvium is mapped as yellow and the granite is mapped as pink.**

Published mapping indicates that the site is underlain by Quaternary alluvium that comprises of gravel, sand, silt and clay. A small portion of the western part of the site is underlain by Palaeozoic granite, gneissic granite and gneiss.

According to the published mapping, it is likely that the Quaternary alluvium is underlain by granite and possibly sandstone which is located to the west of site. Driller's Logs from on-site registered groundwater bores GW403836 and GW403837 indicate granite is present at approximately between 11.5 – 12.0 m below ground level (bgl).

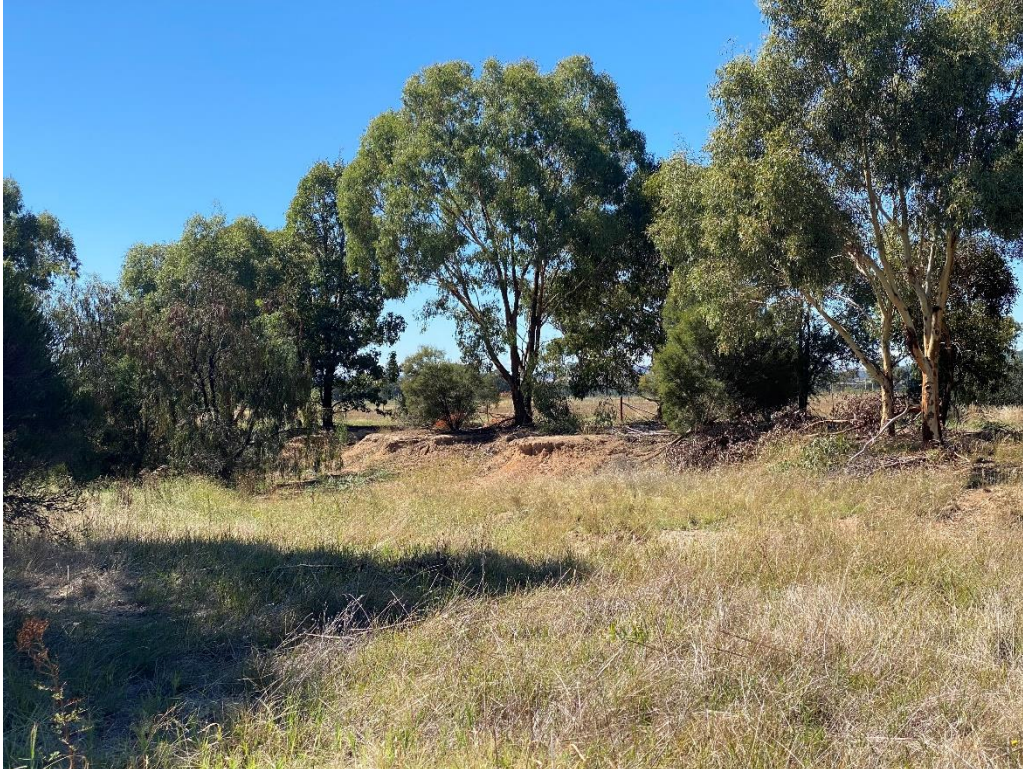
**Figure 7: General view of the Stringybark Creek tributary erosion within the south-west portion of the site, looking south-east.**

- The site was gently undulating and generally sloped down from the south-west to the north-east;
- Gully line erosion was present within the south-west of part of the site (within the Stringybark Creek tributary). Various materials had been tipped in a section of the Stringybark Creek tributary, including vegetation, timber, concrete, brick and cattle carcasses. The soil within the erosion line was up to approximately 3 m deep and no rock was observed within the walls of the gully. The soil comprised a mixture of silty sand and sandy clay with gravel;

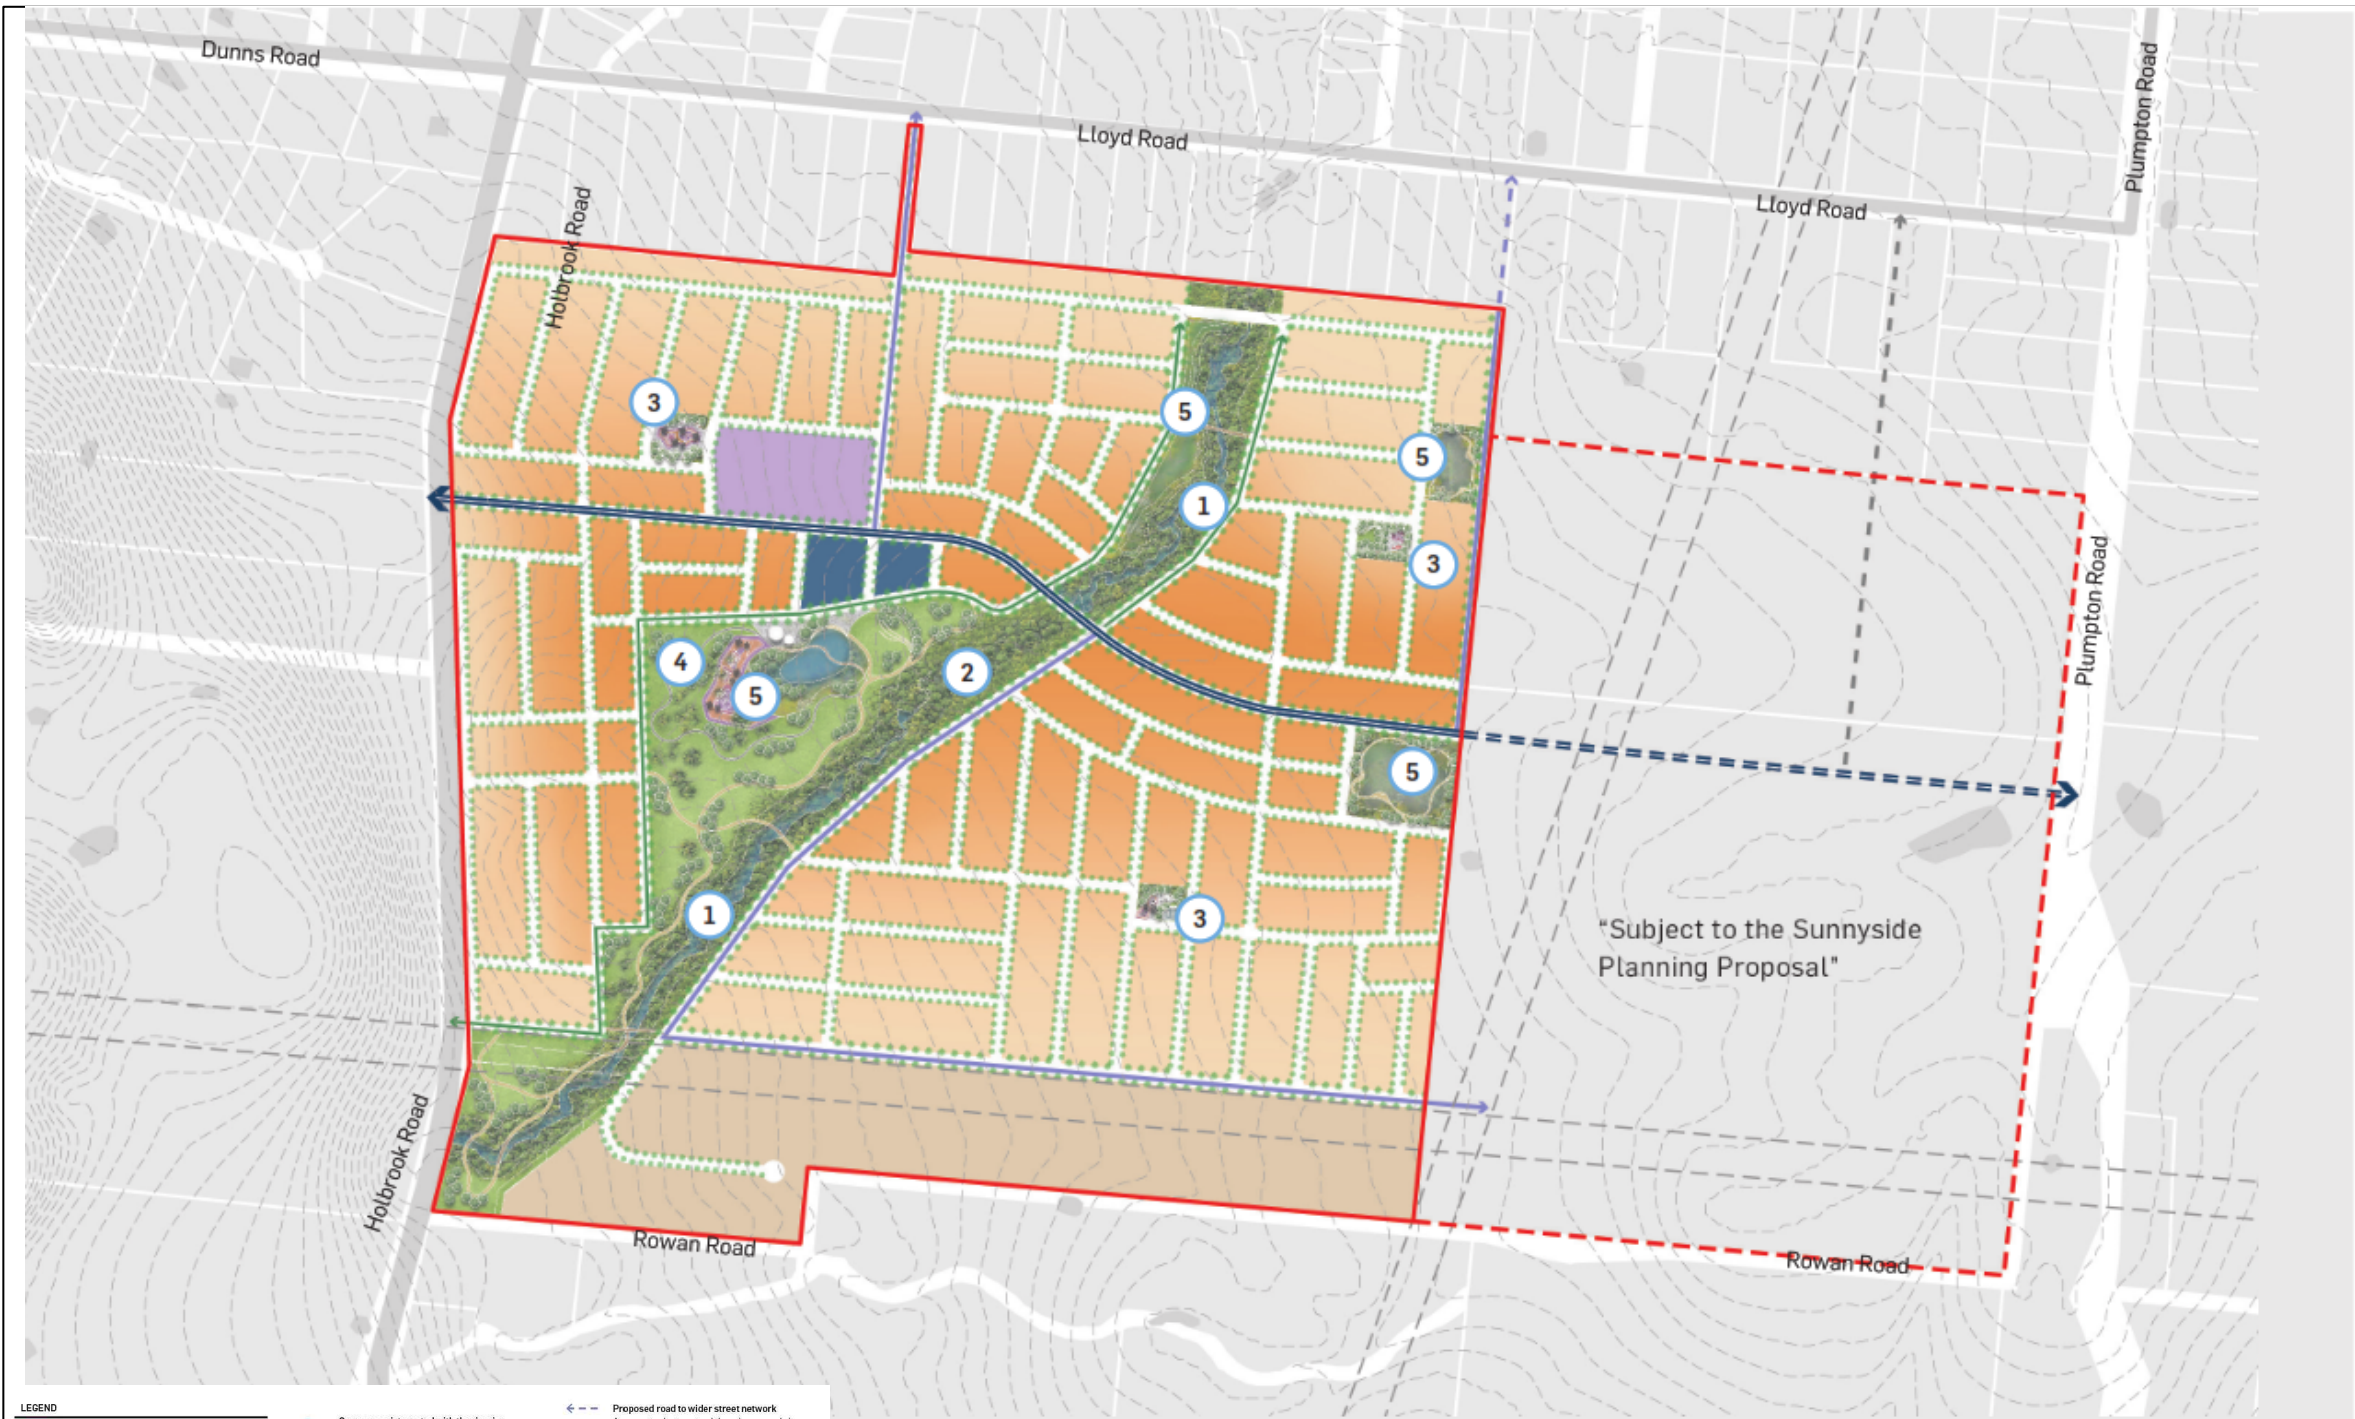
Drawings 1 and 2

- LEGEND**
- Rowan Village (The site)**  
The site has a total area of 225.02 Ha.
  - Sunnyside Planning Proposal- Indicative**
  - 1 Primary Watercourse**  
The primary watercourse of the riparian corridor is categorised as Straller stream order 2 and 3.

- 2 Easements**  
The existing electricity transmission line is located on the southern side of the site.
  - 3 Riparian Corridor**  
The Riparian Corridor includes a high order water course and allows for a buffer of 20-30m from the top of bank on each side. It runs through the centre of the site and is integrated wholly into the open space network.

- 16 Village Residential Area**  
These residential lots will leverage off the close proximity to the local centre and its associated amenities and offerings. Fundamentally, these residential lots will still uphold the low density residential housing charter that the site will deliver, whilst ensuring that an appropriate diversity of housing choice is delivered.

- 17 Seniors Living**  
The senior living component is located adjacent to the collector road, the village centre and the local open space to take advantage of the high amenity and accessibility.

The proposed plan for the subdivision is shown in Drawing 1, Appendix B. It should be noted that the above Planning Proposal details were provided to DP by Urbis and were required to be included in the report as a Pro-Forma section.
