ATTACHMENT 10 – HYDROGEOLOGICAL ASSESSMENT

Planning Proposal – SP20018 – Croft Developments (November 2021)

**121 FERNLEIGH ROAD
TURVEY PARK NSW**

**HYDROGEOLOGICAL
ASSESSMENT**

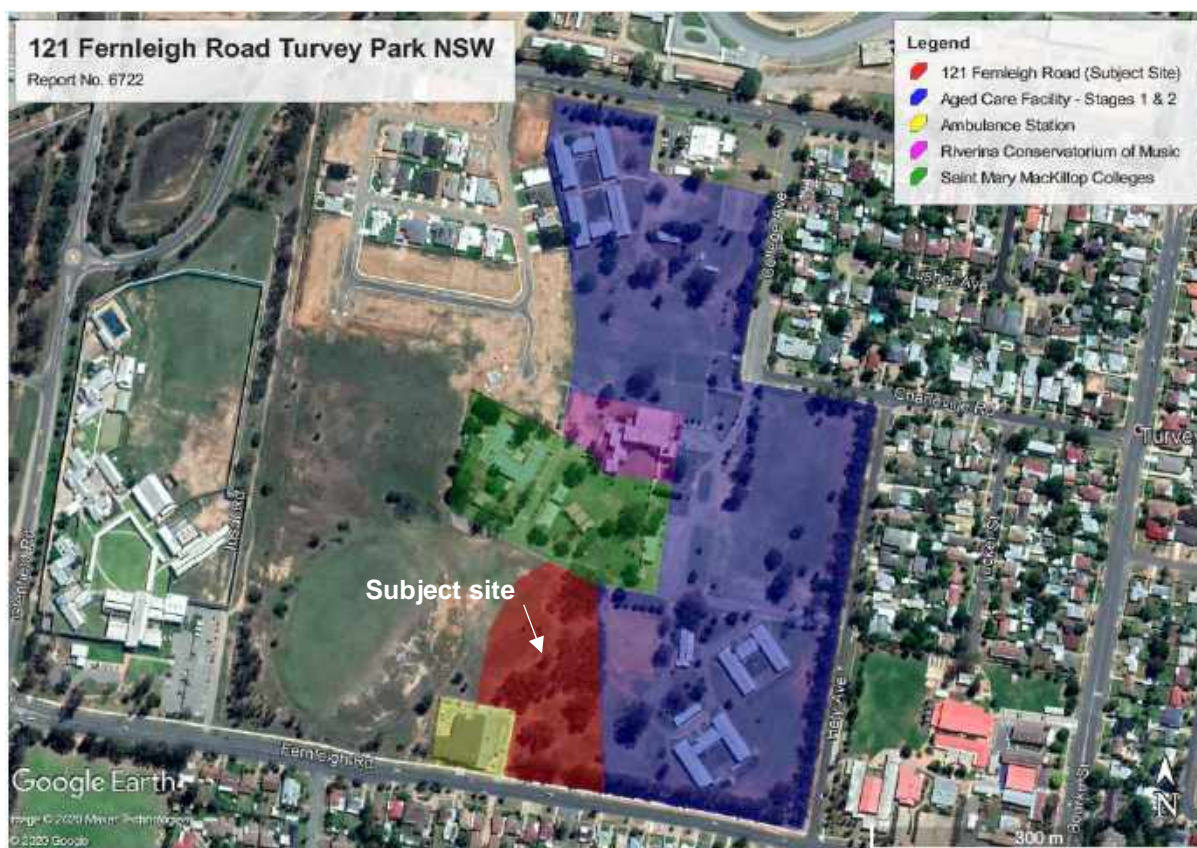
Figure 1: Subject site – 121 Fernleigh Road

The highest point of this site is about 206 mAHD in the south-east fronting Fernleigh Road. The site generally slopes to the north-west with the lowest point being about 197 mAHD in the north-western corner. The subject site lies to the north and eastern boundaries of the Ambulance Station, the southern boundary of the Saint Mary MacKillop Colleges, and the western boundary of the Aged Care Facility Development (Stages 1 & 2), see **Figure 1**.

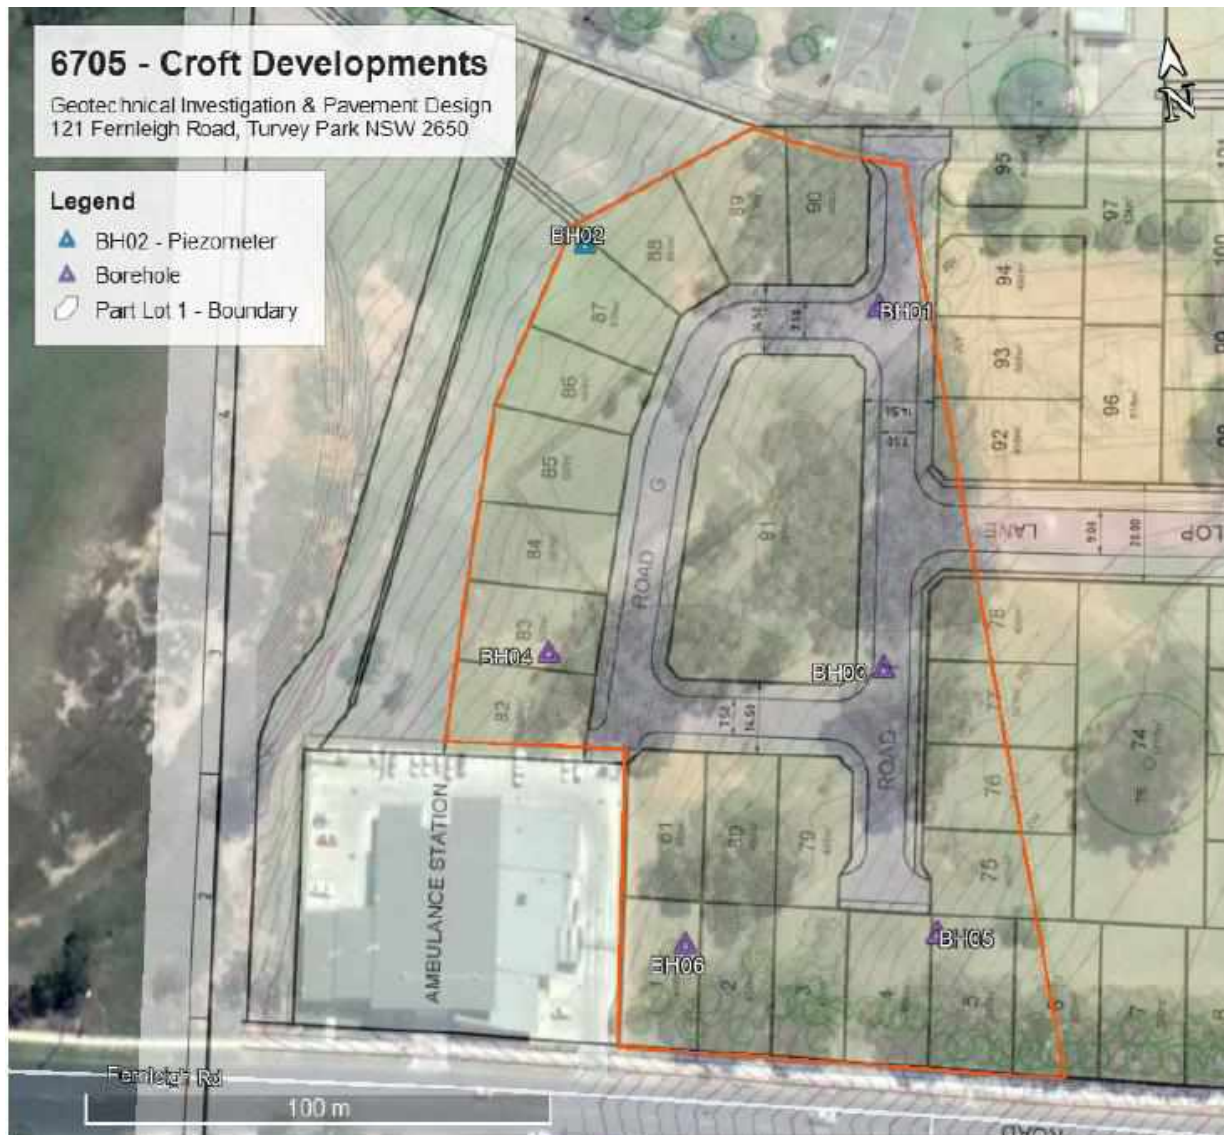
Figure 19: Location of geotechnical sampling sites

The assessment of the site included six geotechnical soil sample sites to capture sufficient data of the potential site variability (Report 6705. McMahon, 2020). The sites are located in a loose grid across the subject site, see **Figure 19**.

From geotechnical investigation, the majority of the sites were drilled to a depth of 1.5m, with one drilled to a depth of 6m (BH02). The only site where moist material was intersected was BH02 from 2.7m to 6m below ground level. The groundwater level was measured post drilling at BH02 at 5.7m below natural surface. The presence of moist material above the standing water level of 5.7m would likely be associated with capillary rise.

The material across the site consisted of yellowish to reddish brown, clay to silty clay with a medium to high plasticity. Subsurface conditions encountered across the site were generally consistent with the landscape forming processes, presenting thin colluvial topsoils overlying thick residual clays derived from parent materials. Investigation locations generally presented fine grained inorganic clay subsoils varying from low to high plasticity. All soil salinity analysis conducted on 1:5 soil/water samples found low salinity soils that ranged between 169 $\mu\text{S}/\text{cm}$ to 695 $\mu\text{S}/\text{cm}$ with a median of 252 $\mu\text{S}/\text{cm}$, see **Attachment B**. These results show no influence of evapoconcentration of saline groundwater has likely occurred on the site and therefore it is unlikely that there have ever been saline shallow groundwater levels beneath the site.

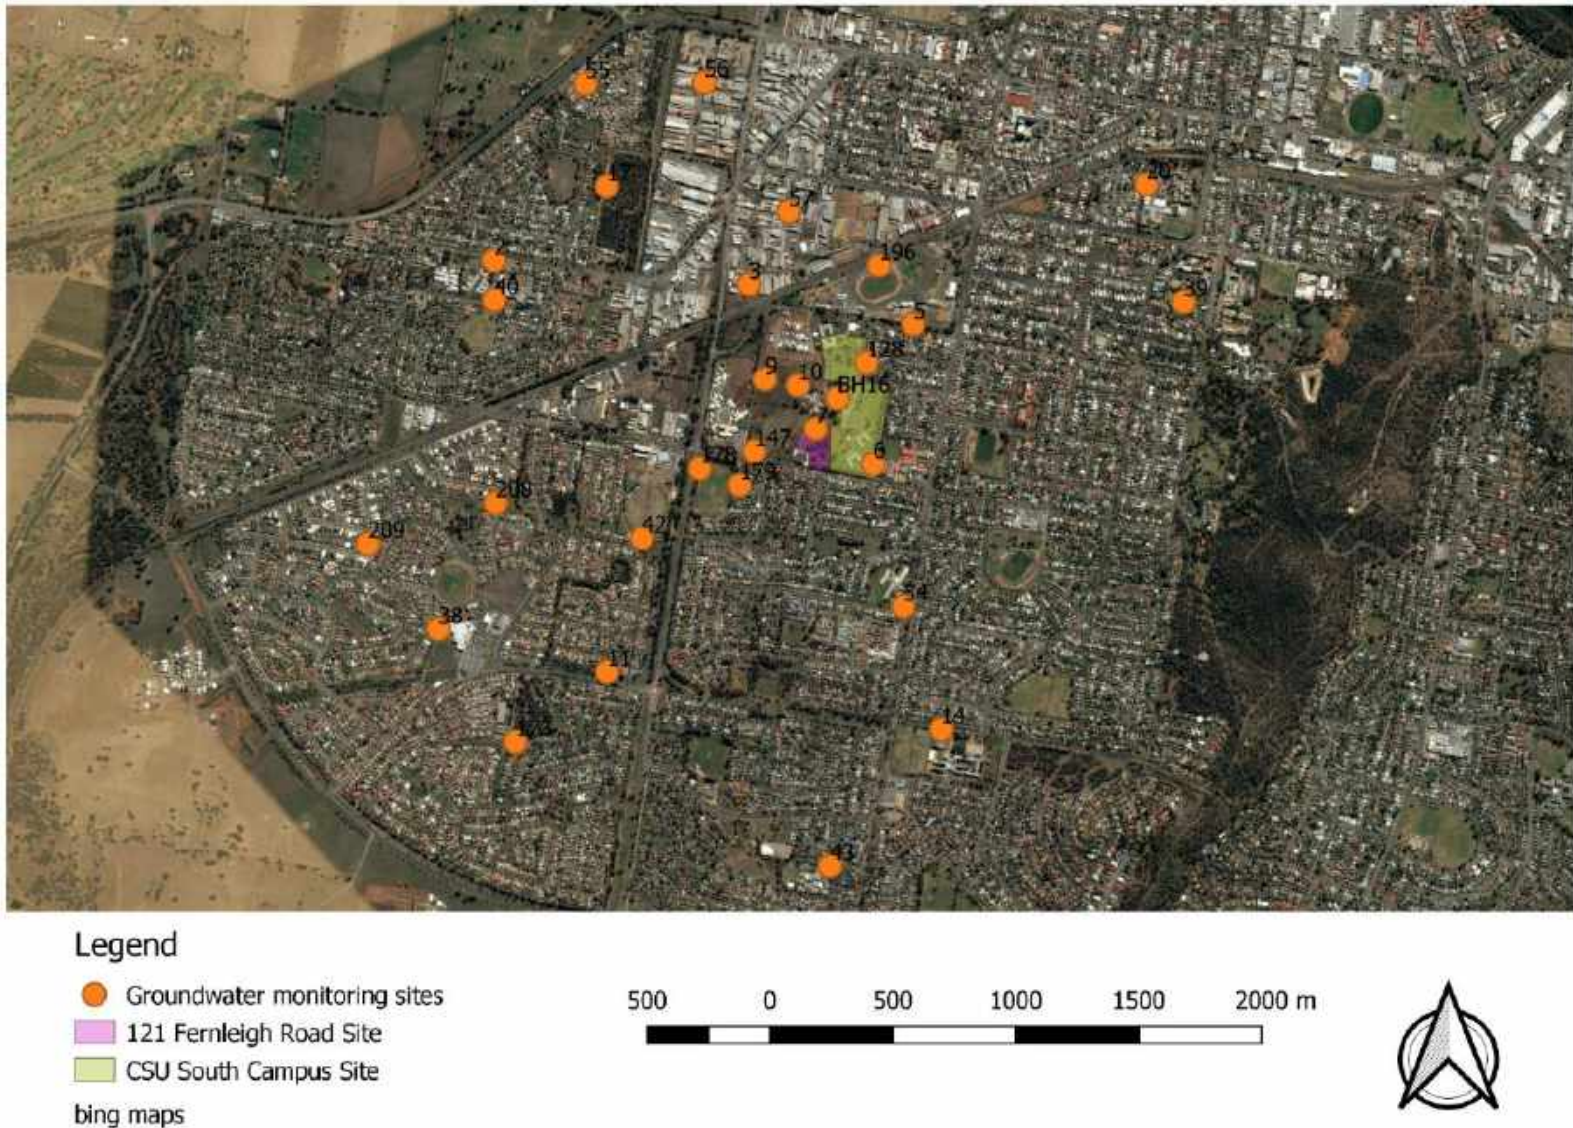
Figure 21: WWCC groundwater monitoring sites included in this investigation

The 30 WWCC sites included in this assessment included 22 sites defined as being associated with a deep groundwater system and 8 with a shallow groundwater system. Seven of the deep sites were either damaged or have no groundwater present, whilst 3 of the 8 shallow sites were either dry or damaged.
