ATTACHMENT 6 – SITE AUDIT REPORT

SITE AUDIT REPORT

**20 Hely Avenue, Turvey Park NSW
Remediation Action Plan**

Date: July 2020

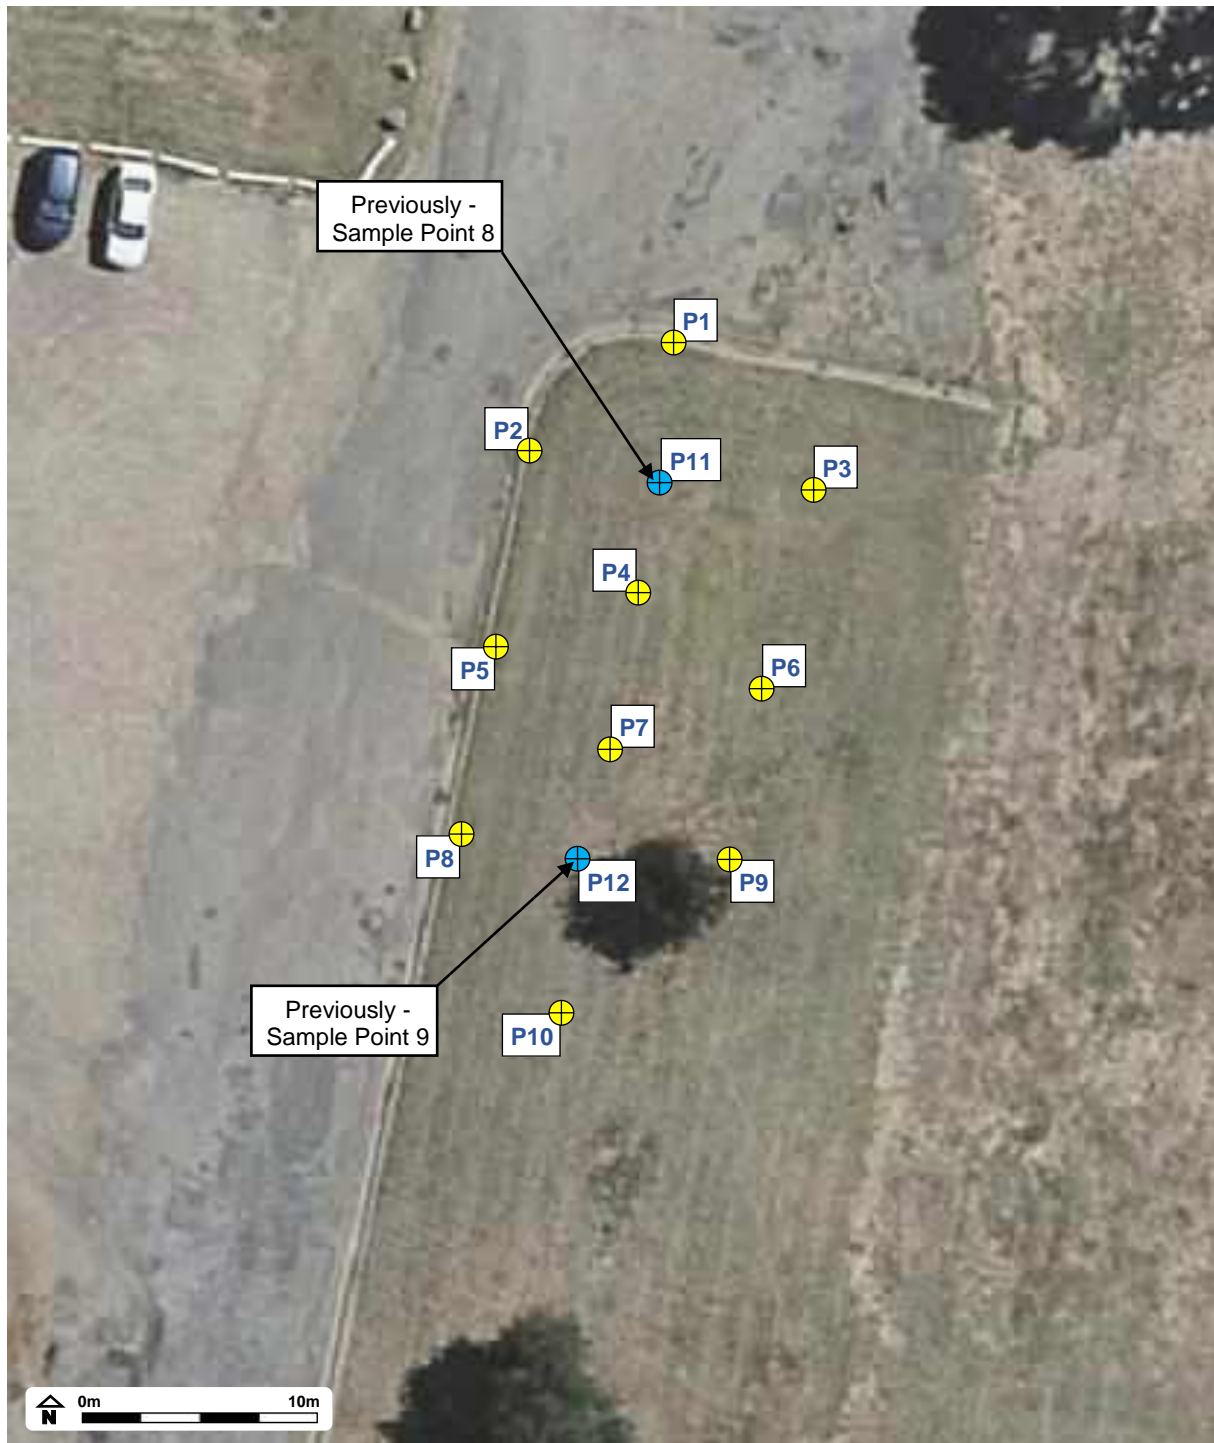
Figure 8: Additional PAH sampling

- Two sampling points (8/1 & 9/1) located within AEC 2 (RAAF boiler room and incinerator) in the vicinity of the former boiler room were noted to contain marginally elevated concentrations of B(a)P (0.8-1.1mg/kg) compared to the EIL (0.7mg/kg). This triggered further grid sampling across the area (P1-10) (Figure 8) which confirmed some localised low-level B(a)P impact with a maximum concentration of 4.5mg/kg. Similar concentrations were identified in the vicinity of the workshop (WO) located adjacent to the boiler room/incinerator. This is associated with ash from the former boiler/incinerator (which was identified in the borelogs) and is not considered to be bioavailable.

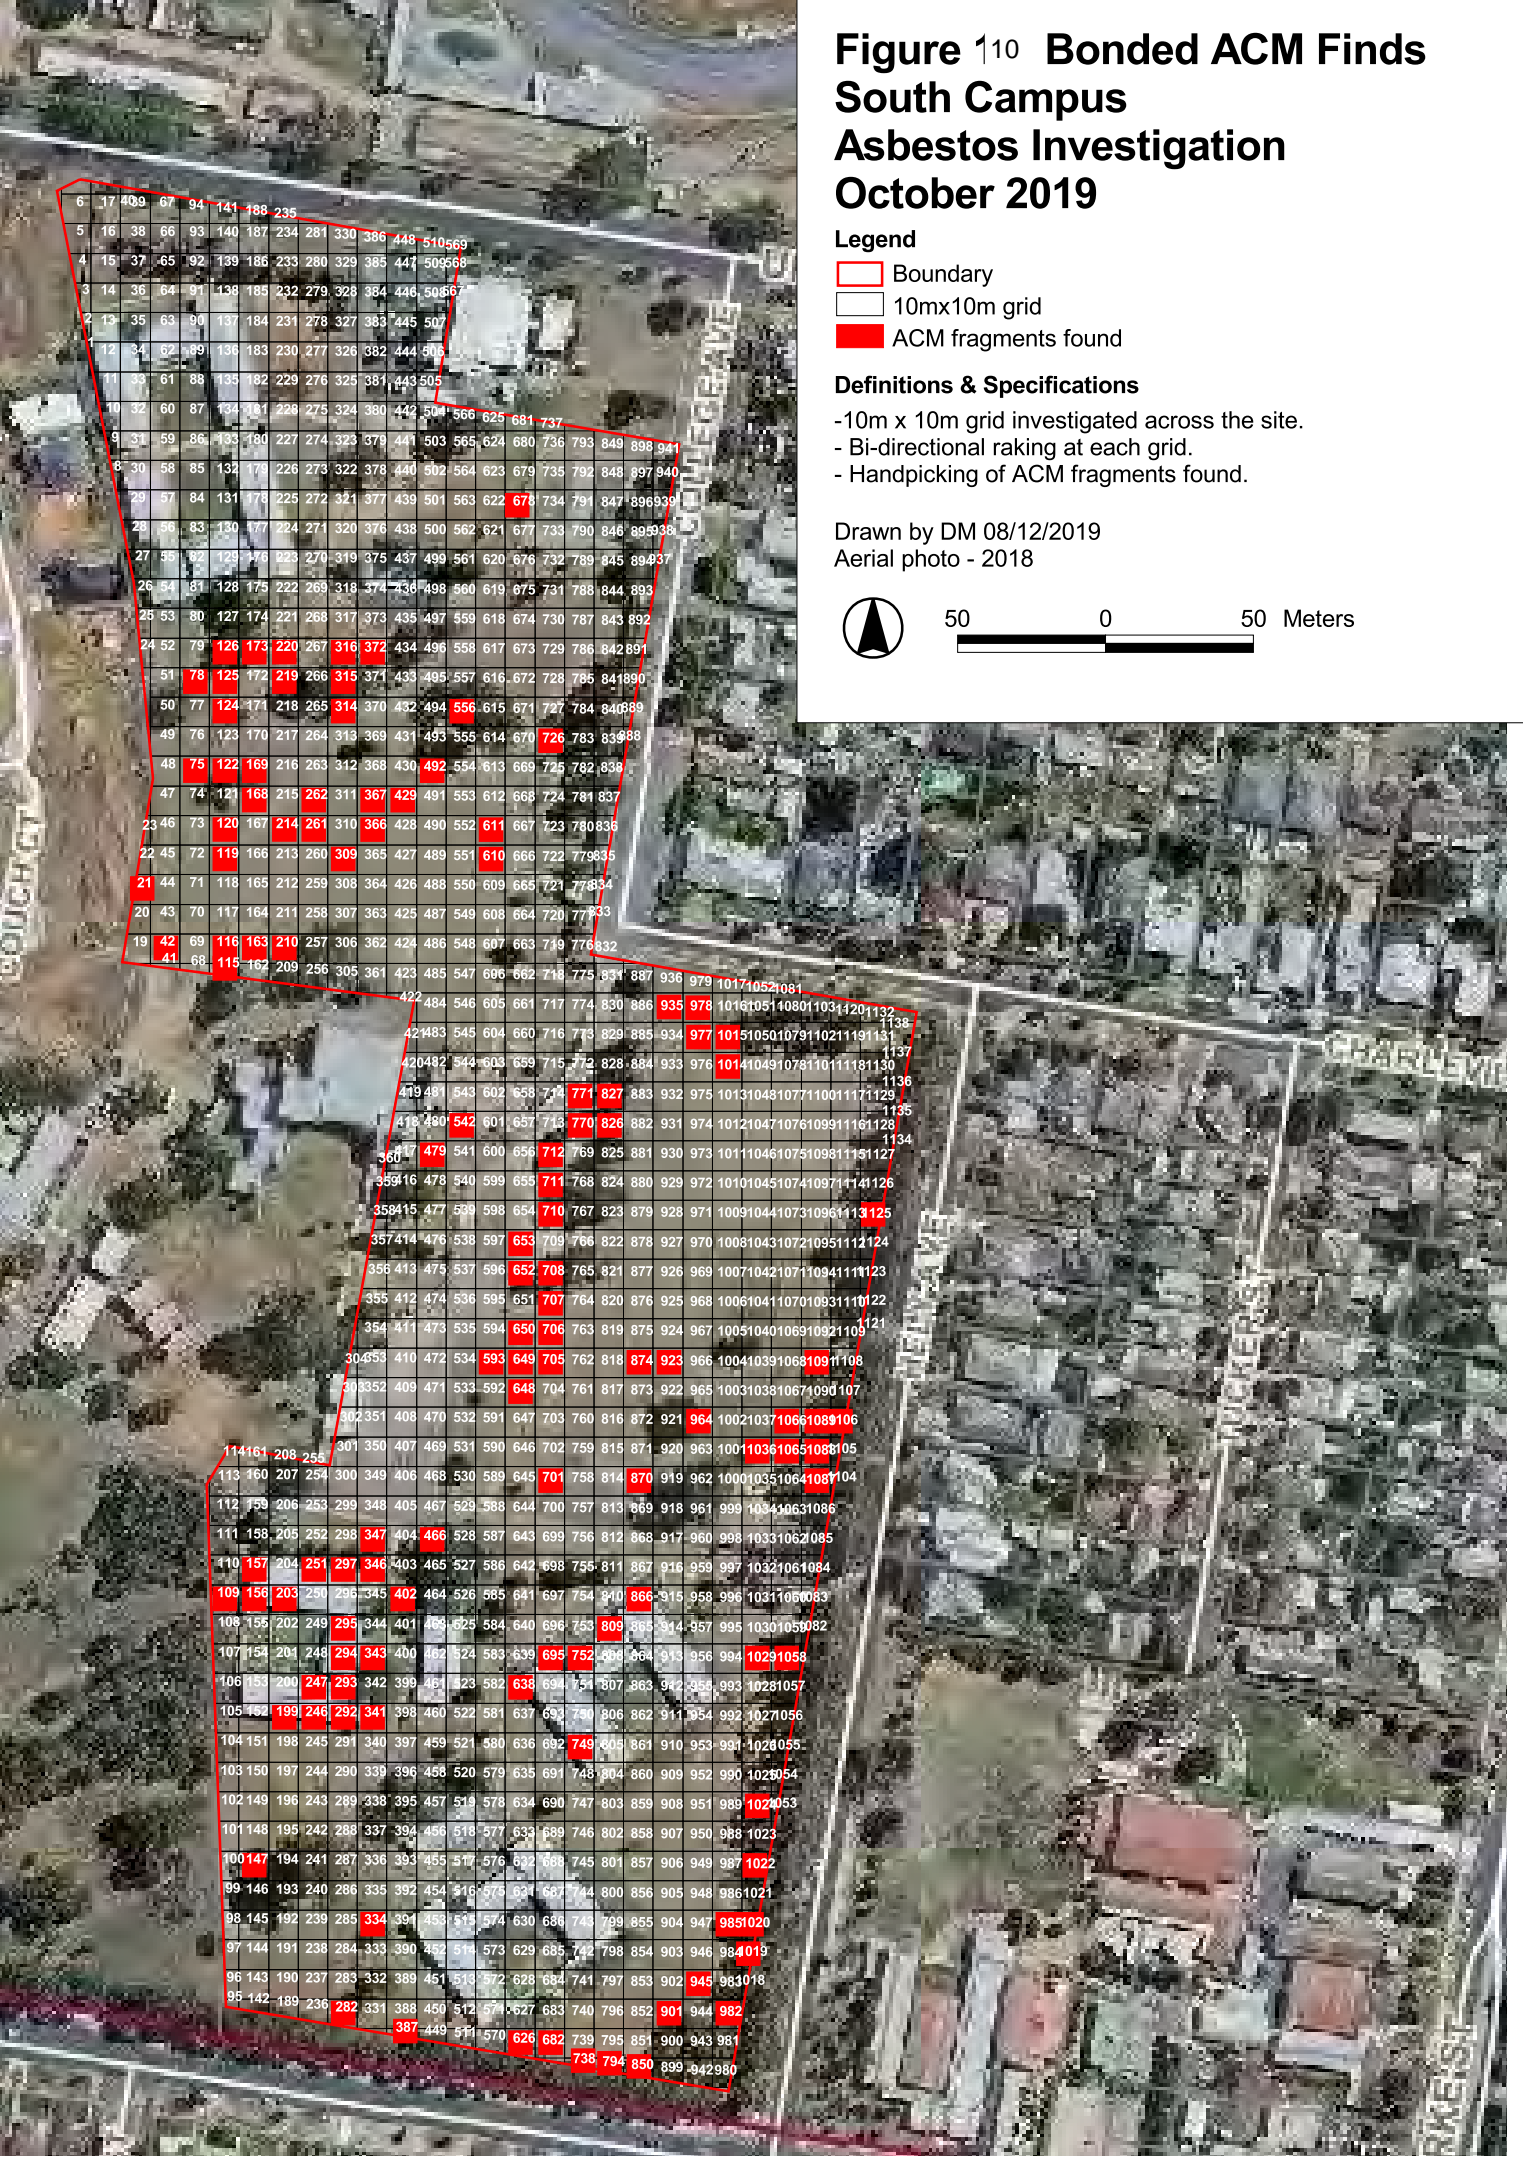
Figure 11 Asbestos sampling South Campus Asbestos Investigation November 2019

- 10m x 10m grid investigated across the site.
- Bi-directional raking at each grid.
- Handpicking of ACM fragments found.
